# Epoxy Bleedout in Ceramic Chip Carriers

James E. Ireland  
Medtronic Corporation  
Tempe, Arizona

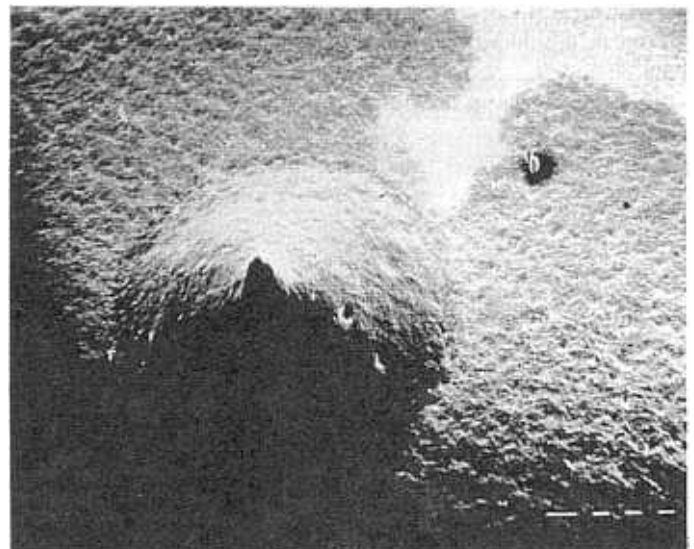
In the initial testing, both the Abelbond and Epotek epoxies exhibited a very severe bleeding problem on the vendor B chip carriers (see Figures 1 and 3). On the vendor

Figure 1. Typical resin bleedout on a vendor B chip carrier using H2OE epoxy.

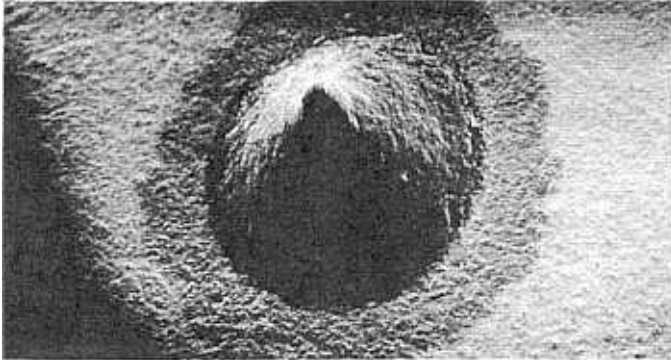
A parts, both epoxies showed either no bleeding or only a minor bleed halo (see Figure 2). There were notable differ-

**Figure 2. Worst case bleedout on a vendor A chip carrier using H20E epoxy.**

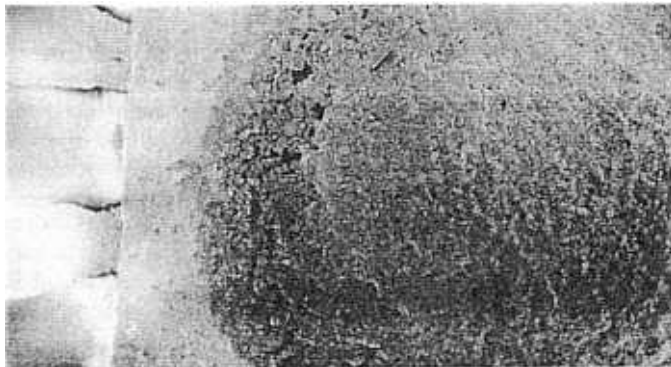
**Figure 3. Abelbond 773-6 epoxy on a vendor B chip carrier. Note the spread of silver particles at the dot edge. Mag. 53X**

wicked rapidly outward, causing an actual physical collapse of the original dot (see Figure 3). In some samples, silver particles were actually carried away from the original dot and accumulated in the package corners.

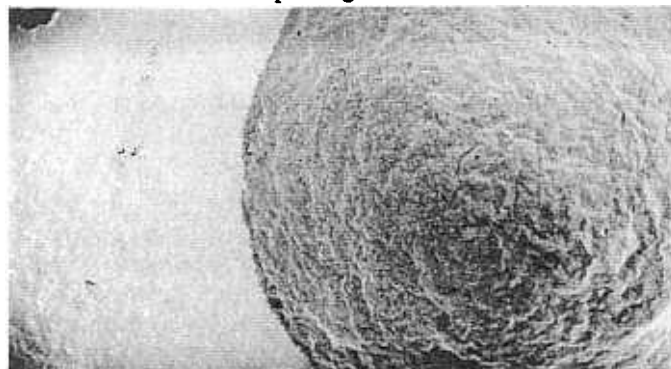
**Figure 3A. Abelbond 773-6 epoxy on a vendor B chip carrier that was vacuum baked four hours at 250°C before dispensing of the epoxy. Note the absence of resin separation at the dot edge.**

bleedout in both groups. Interestingly, recleaning of the of the vacuum baked parts did not induce new bleedout. Figures 2, 3, 3A, and 3B illustrate the results obtained from the Table 1 experiments. Note the total absence of resin separation and the specific non-wetting, convex meniscus at the edge of the epoxy dot on the vacuum baked samples. This effect is particularly pronounced with the Abelbond epoxy, as shown in Figures 3 and 3A.

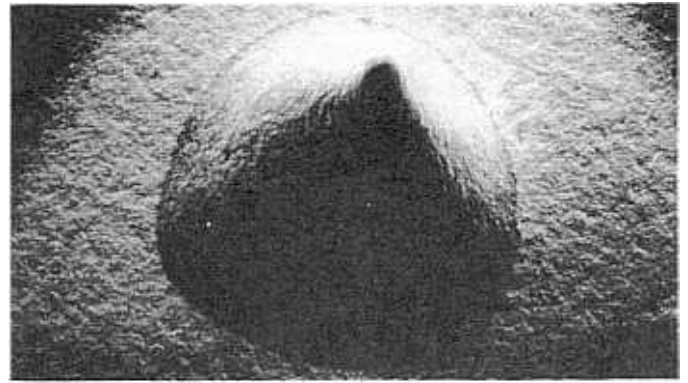
**Figure 3B. H20E epoxy on a four hour vacuum baked vendor B chip carrier.**

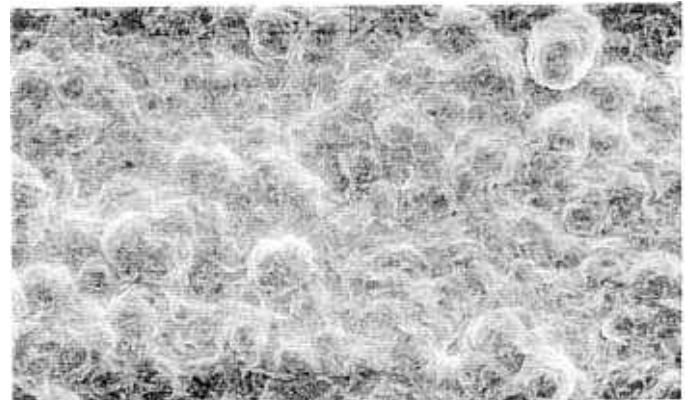
As can be seen in Figure 4, the surface of the vendor A part was found to be relatively smooth and void free.

**Figure 4. Vendor A bonding area surface. Mag. 1090X**

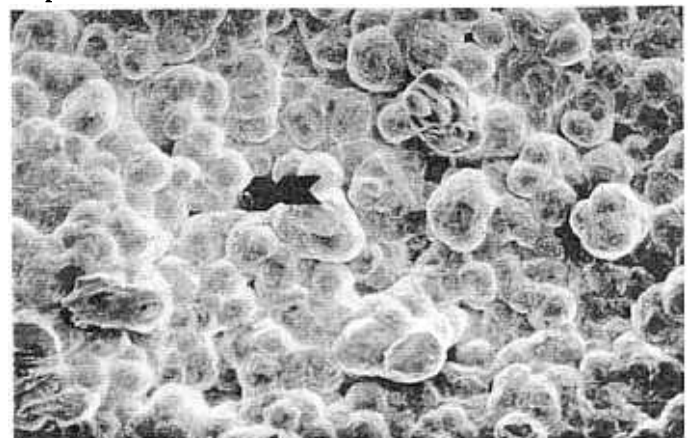
In contrast, surfaces of the vendor B parts, shown in Figure 5, have a much grainier and obviously porous appearance. It is believed that this surface porosity promoted resin spreading through capillary transport and accounts for the observed severity and extent of bleedout in the vendor B chip carriers.

**Figure 5. Vendor B bonding area surface. Mag. 1090X**
