Epoxy Bleedout in Ceramic Chip Carriers

James E. Ireland
Medtronic Corporation
Tempe, Arizona

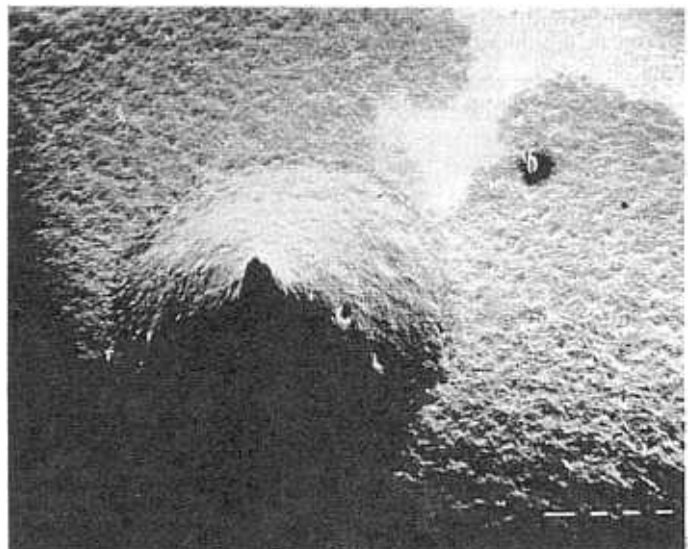
In the initial testing, both the Abelbond and Epotek epoxies exhibited a very severe bleeding problem on the vendor B chip carriers (see Figures 1 and 3). On the vendor

Figure 1. Typical resin bleedout on a vendor B chip carrier using H2OE epoxy.

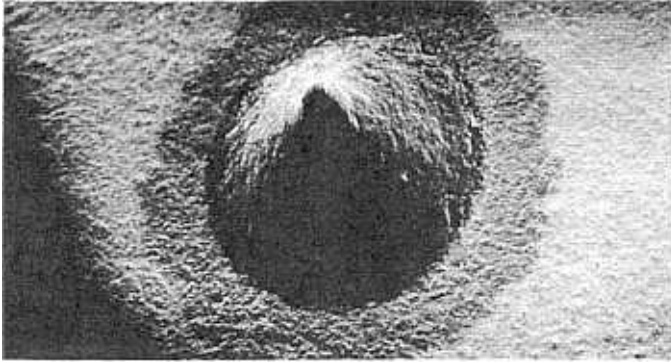
A parts, both epoxies showed either no bleeding or only a minor bleed halo (see Figure 2). There were notable differ-

Figure 2. Worst case bleedout on a vendor A chip carrier using H20E epoxy.

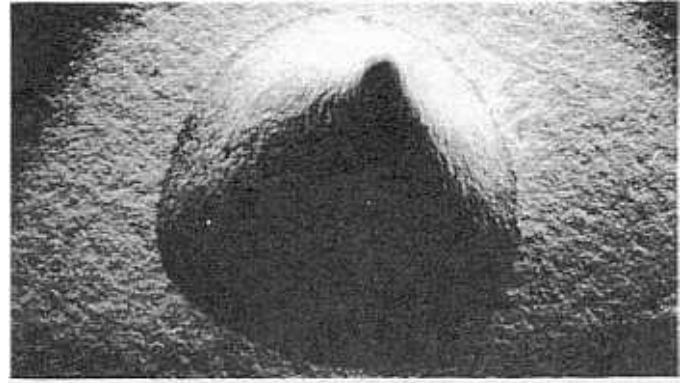
Figure 3B. H20E epoxy on a four hour vacuum baked vendor B chip carrier.

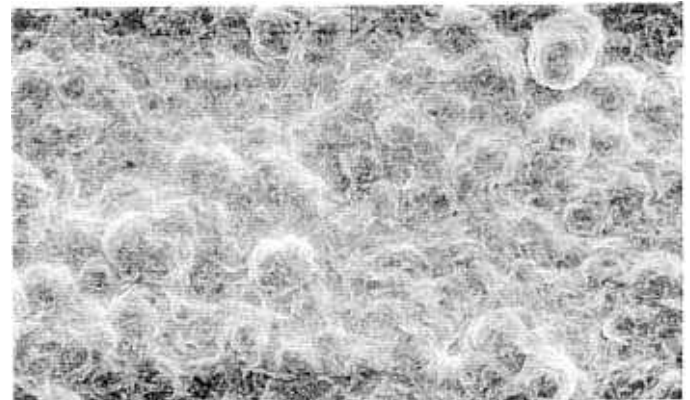
As can be seen in Figure 4, the surface of the vendor A part was found to be relatively smooth and void free.

Figure 4. Vendor A bonding area surface. Mag. 1090X

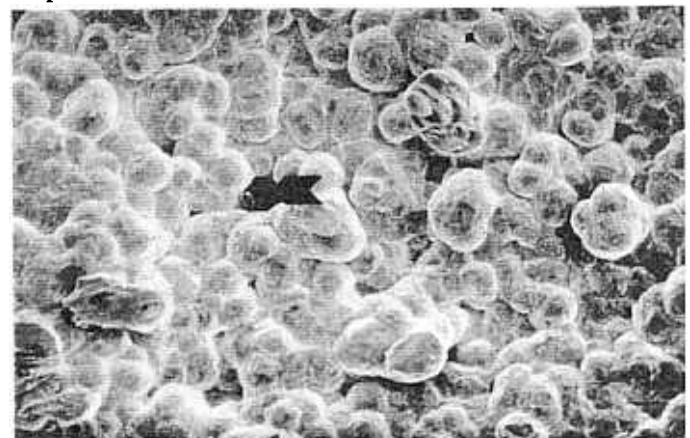
In contrast, surfaces of the vendor B parts, shown in Figure 5, have a much grainier and obviously porous appearance. It is believed that this surface porosity promoted resin spreading through capillary transport and accounts for the observed severity and extent of bleedout in the vendor B chip carriers.

Figure 5. Vendor B bonding area surface. Mag. 1090X
