# Epoxy Bleedout in Ceramic Chip Carriers

James E. Ireland  
Medtronic Corporation  
Tempe, Arizona

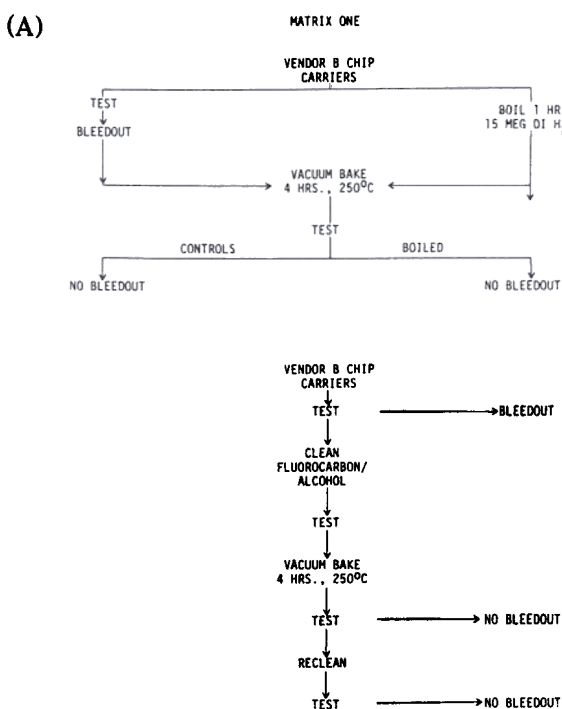
TABLE 1

In an attempt to detect the presence of such surface contamination, the series of tests shown in Table 1 was performed. The first test was for inorganic plating bath salts or other water soluble compounds. A group of known bleeding vendor B chip carriers was boiled in 15 megohm deionized water for one hour. These parts, along with a group of unboiled controls, were then vacuum baked for four hours at 250°C and 100 millitorr. This was initially done only to ensure that the boiled parts were free of residual water. Amazingly, when bleed testing was performed, it was found that bleedout had been eliminated in both the control and boiled samples. Evidently, the vacuum baking step had somehow acted to eliminate the resin bleedout.

The results of this experiment indicated that some type of adsorbed yet volatile surface contamination was present on the chip carriers. The vacuum baking process was investigated further by baking an additional group of vendor B parts. Once again epoxy bleedout was eliminated. Some of these vacuum baked parts were then allowed to stand in room air for 24 hours to determine whether surface absorbed moisture might be the causative factor of resin bleeding. After 24 hours, these parts still exhibit no signs of bleedout. In fact, later testing has shown that the bleeding phenomena do not return even after long periods of room air exposure.
